Manhole Inspection Summary

Manhole # S45CC_025MH

Insp Date: 11/21/08 11:33 AM

Location Address: **rear 1811 chase st**

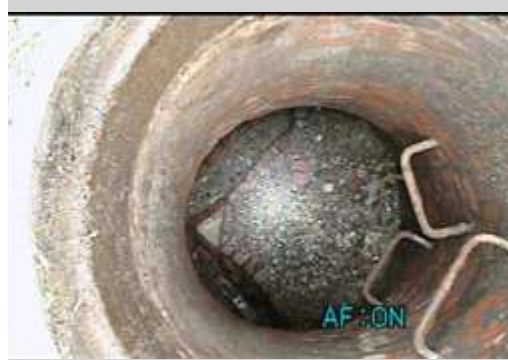
Top View

Condition: ☐ Sound ☒ **Cracked** ☐ Root Intrusion ☒ **Loose Brick** ☒ **Deteriorated**

Condition: ☐ Sound ☐ Cracked ☐ Root Intrusion ☐ Deteriorated ☐ Leaks ☒ **Debris**

Steps Count: **4** Missing: **0** ☒ **Corroded**

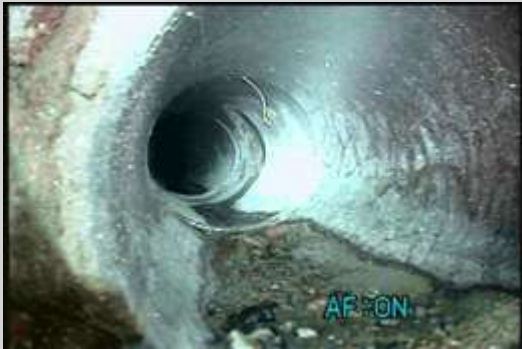
12 O'Clock Outflow

8 in. Circular Gravity Sewer
Pipe Out @ 12 O'Clock

Pipe Material: **Clay** ☐ Pipe Lined

Invert Depth: **7.79** (ft.) Flow Characteristics: **None**

Deposits: ☒ None ☐ Mud ☐ Sludge ☐ Debris ☐ Grease

Infiltration: **None** Pipe Seal Cond: **Unknown**

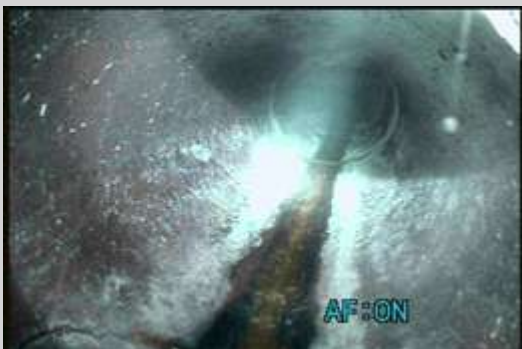
6 O'Clock Inflow

8 in. Circular Gravity Sewer
Pipe In @ 6 O'Clock

Pipe Material: **Clay** ☐ Pipe Lined

Invert Depth: **7.66** (ft.) Flow Characteristics: **None**

Deposits: ☒ None ☐ Mud ☐ Sludge ☐ Debris ☐ Grease

Infiltration: **None** Pipe Seal Cond: **Unknown**

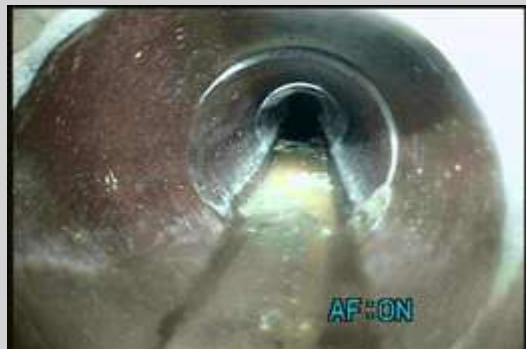
9 O'Clock Inflow

8 in. Circular Gravity Sewer
Pipe In @ 9 O'Clock

Pipe Material: **Clay** ☐ Pipe Lined

Infiltration: **None**
